Cycle-PO₄ and HydroCycle-PO₄ Product Problems and Service-time Update

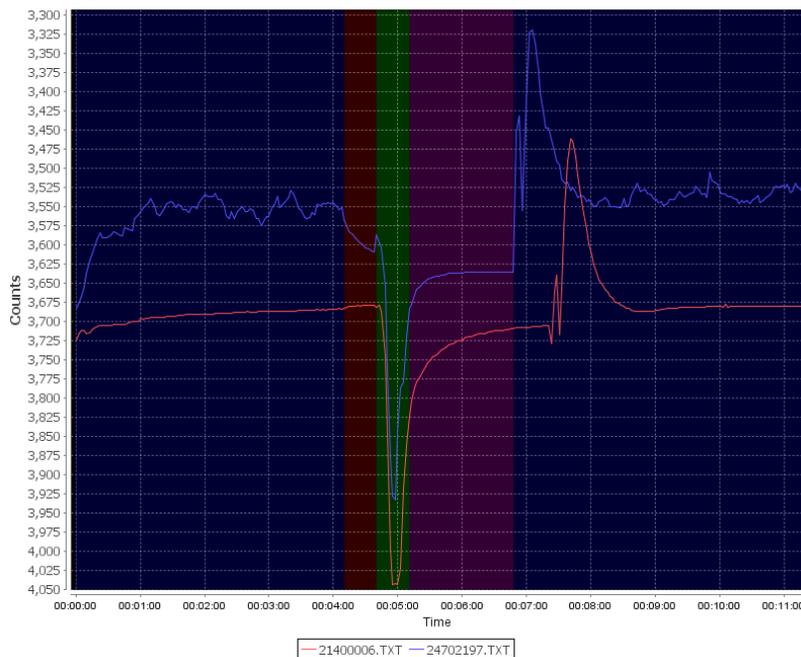
Example of baseline noise issue:

3: Increased baseline noise) A few months after the duckbill valve material change a noisy baseline was observed for some units in our 5-m deep “silo” mock deployment. This test uses tap water, rather than the lab water used in most factory testing. We did not have test criteria around the silo noise, but an experienced service technician noticed unusually noisy pump performance, raised flags, and we have evolved our test criteria to set limits for baseline pumping noise during this test. We sincerely apologize for this error and if your recently serviced unit is affected by increased baseline noise please contact support@seabird.com (see example raw data below). We have yet to fully identify the root cause of the baseline noise and will continue to investigate this issue until we have a solution.

Note the relative flatness of the ideal red trace (lower) in the first 4 minutes and the regular “random” noise in the baseline noise affected blue trace (upper).
