Wet Pluggable Connector Material Issue and Replacement Plan

Issue:

Certain Sea-Bird Scientific sensors have electrical bulkhead connectors that may fail due to a change in material by our supplier. The bulkhead connectors in question are the MCBH wet-pluggable versions. This issue does not apply to XSG connectors.

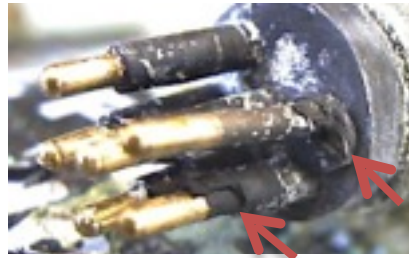
The failure mode includes corrosion and weakening of the pins, especially the power pin, which may result in pins breaking and getting stuck inside cables. ***Bulkhead failure will not cause flooding of the sensor.***

Failure is most frequently seen in moored applications in shallow/warm water that are connected to external power.

Broken, missing, or corroded pin

*Material degraded
"loose-sock effect"*

Please review the attached **photos** of “affected” and “OK” connectors on the last page of this document. If you believe your connector is affected, contact the appropriate service department as shown in the table below to schedule replacement of your connector. Sensors are currently being built with validated connectors that are unaffected by the issue; the supplier has discontinued use of the material.

- Sensors not requiring service will only have connectors replaced.
 - Please **obtain a RMA** and note only connector replacement.
 - Sea-Bird Scientific will cover the cost of shipping the sensor (both ways).
- Sensors already planned for standard evaluation/service will have the bulkhead connectors inspected and replaced free of charge if needed.
 - Please **obtain a RMA**.
